Infrared thermal imaging to inspect pathologies on façades of historical buildings: A case study on the Municipal Market of São Paulo, Brazil

Maurício M. Resende^a, Enrico B. Gambare^a, Letícia A. Silva^a, Yuri de S. Cordeiro^a, Eneida Almeida^b, Renan P. Salvador^{a,*}

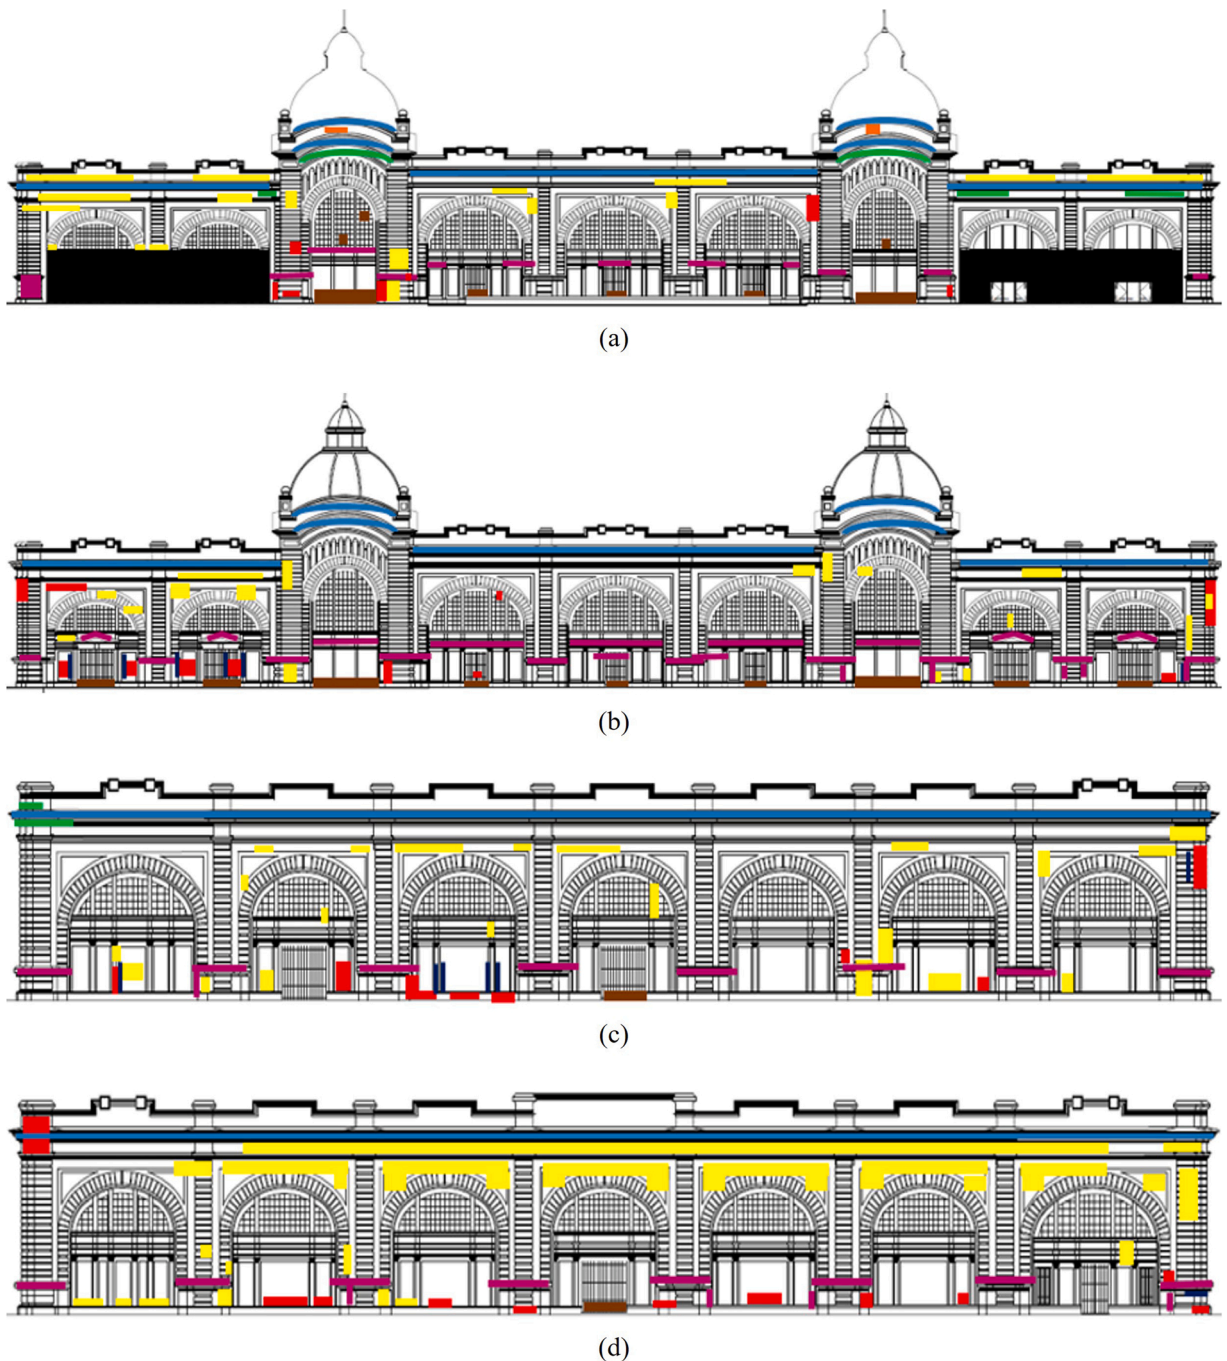
The mapping of the pathologies present on the façades of the Municipal Market of São Paulo is shown in Fig. 7. The identification of each damage is presented in Table 1. The central anomalies found were the detachment of the rendering mortar, cracks, blisters, mold, biological growth, paint disintegration, damage to door and window frames, and the presence of dirt. Remarkably, the damage degree is more easily observed in the thermograms than in conventional images, which show only minor differences between intact and damaged areas.

In general, few regions with cracks and blisters were found. The detachment of the rendering mortar occurs at the bottom part of the façades due to mechanical actions and impacts caused by the transportation of goods. Furthermore, such manifestation occurs in the corner regions and protruding elements of the façades.

Mold may be found on the upper part of the façades, near flashings, gutters, and piping for rainwater. This indicates the possibility of water infiltration in these regions, leaving them with greater humidity and favoring the formation of biofilms. Some parts containing biological growths were also found.

The disintegration of the paint is observed in the upper part of the door cornices. The south façade is the most affected by this damage due to the lower incidence of sunlight, which leads to greater humidity in the coating and favors dust formation. In addition, the door frames, originally made of cast iron, were oxidized at the bottom parts close to the ground due to the action of urine and washing water.

Fig. 7. Mapping of damages on the façades: east (a); west (b); north (c); south (d).

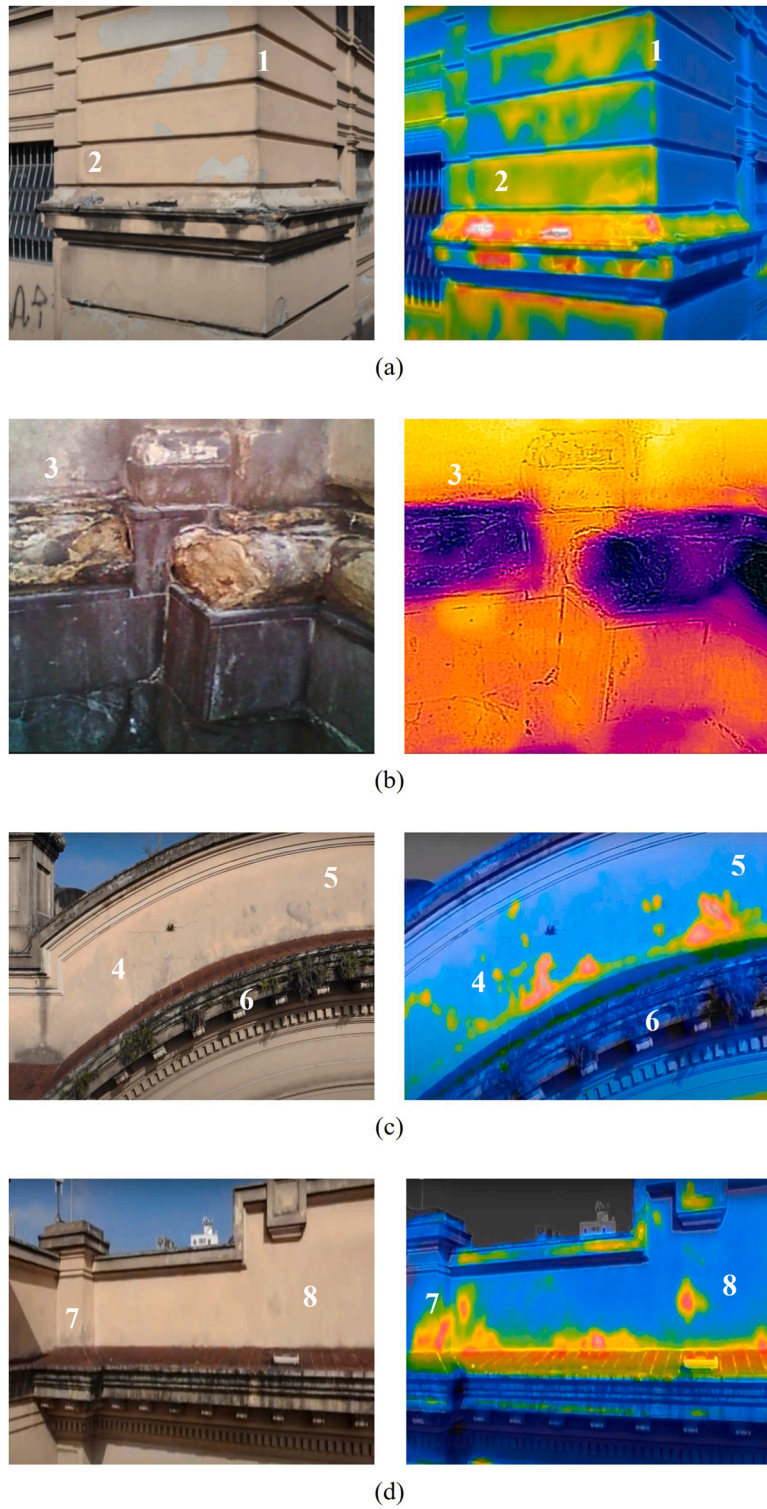
Fig. 8 shows in greater detail the damages observed on the building's façades. The damages identified occur due to moisture from the runoff of rainwater. Thus, thermal anomalies are observed in regions close to cornices, frames, and projections. For example, Fig. 8.a shows the disintegration of paint, identified in the thermogram by areas with higher surface temperature (yellow color) in relation to intact areas (blue color). In addition, an accumulation of dirt and detachment of the rendering mortar on the cornices, identified as thermal anomalies in the thermogram by higher surface temperatures (red color), may be found.

In Fig. 8.b, the thermogram indicates the total detachment of the rendering mortar in a humid region (purple color), represented by a surface with a lower temperature than the intact area (orange color). The detached region presents a higher surface temperature since the air pockets inhibit heat propagation to the substrate. Fig. 8.c shows areas with biological growth and loss of adherence of the paint, which causes air pockets and inhibits heat transfer to the substrate. Therefore, these regions present a higher surface temperature (red color) than the intact part (blue color). Similarly, Fig. 8.d also shows regions with loss of adherence of the paint, identified by the red areas in the thermogram.

Fig. 8. Conventional images (left) and equivalent thermograms (right) of the main damages identified on the façades of the Municipal Market of São Paulo: (a) loss of adherence of the paint (1) and accumulation of dirt and detachment of the rendering mortar on the cornices (2); (b) detachment of the rendering mortar (3); (c) loss of adherence of the paint (4 and 5) and mold (6); (d) detachment of the rendering mortar (7 and 8).

It is necessary to take urgent actions related to waterproofing the roof and draining the rainwater. To install a new waterproofing system, the mechanical protection, the existing waterproofing system, and the rendering mortar must be removed from the façades. In addition, a new project for the roof must be elaborated, including flashings, gutters, and dimensioning of the rainwater drainage ducts, for subsequent execution. The primary sources of moisture that damage the façade components will be eliminated by performing these

The repair procedure should be determined in a small area of the façade for validation of the process. Next, it is recommended to wash the façades for a further evaluation of the adherence of the paint and rendering mortar, which may be performed by infrared thermal imaging using a high-resolution camera (1024 × 768 pixels) or percussion tests. The washing of the facade should be conducted using a water jet under pressure with a fan-type nozzle (opening at 45°), neutral detergent, and a soft brush. In regions where graffiti is present, an organic solvent should be used to remove stains before washing.

Areas with adherence problems must be removed by sawing, followed by cleaning and preparation to receive the new rendering mortar. After at least 72 h, a new layer of rendering mortar should be applied. Finally, the materials used to fabricate the original rendering mortar must be evaluated to produce a cementitious matrix with equivalent properties to repair the detached areas [30,31].
