Infrared thermal imaging to inspect pathologies on façades of historical buildings: A case study on the Municipal Market of São Paulo, Brazil

Maurício M. Resende^a, Enrico B. Gambare^a, Letícia A. Silva^a, Yuri de S. Cordeiro^a, Eneida Almeida^b, Renan P. Salvador^{a,*}

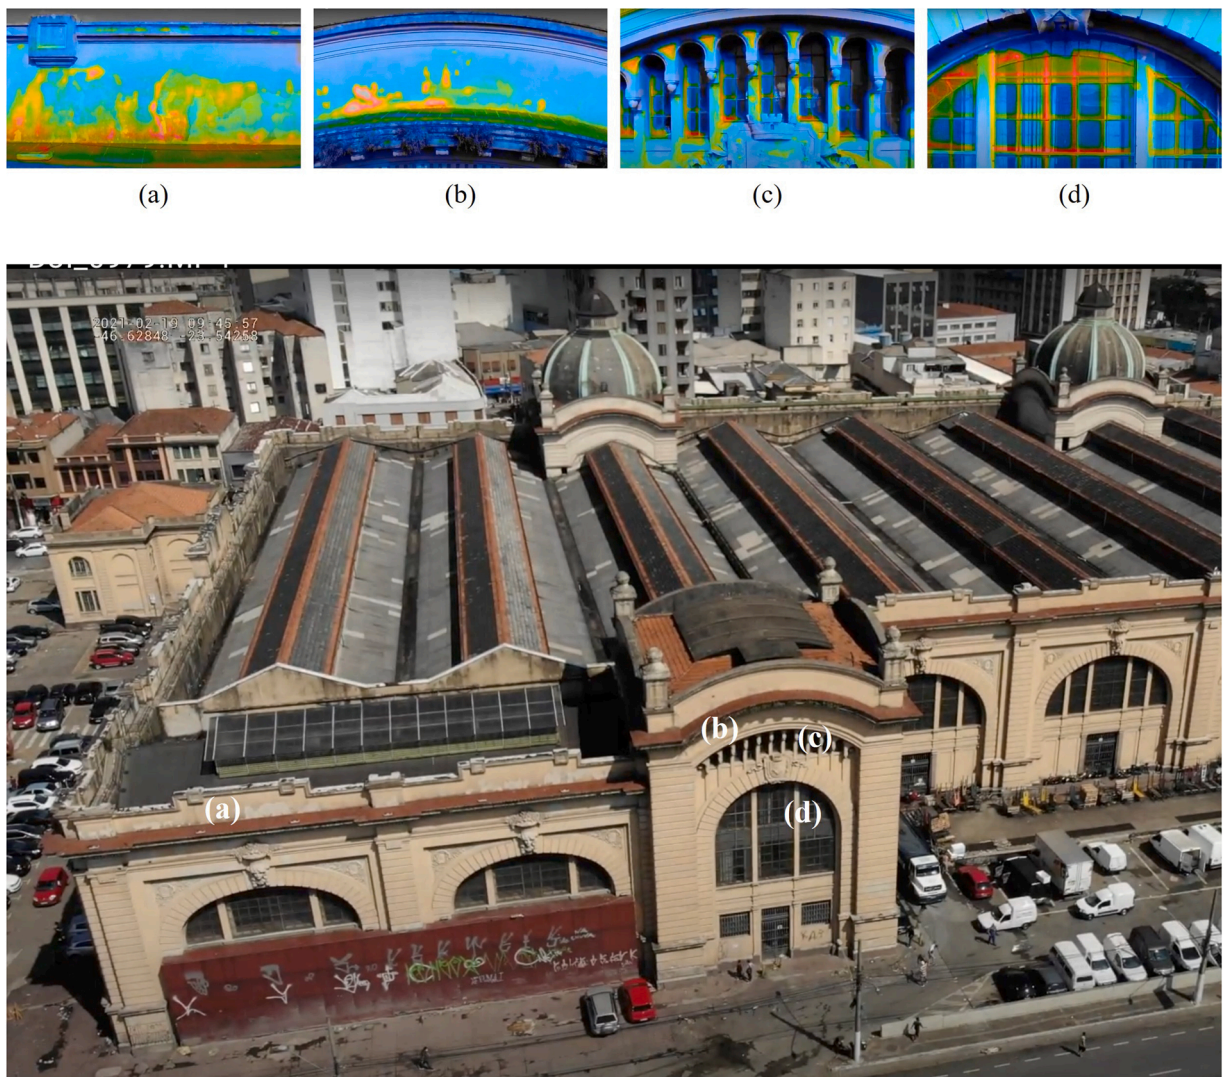
Fig. 3 illustrates possible applications of infrared thermal imaging to inspect historical buildings. By comparing conventional and infrared thermal images, it is possible to map the occurrence of building pathologies. Moreover, combining conventional and infrared

Fig. 3. Examples of building pathologies identified in cultural assets by infrared thermal imaging: detachment of the rendering mortar (a); the presence of mold (b); loss of adherence of the paint (c); corrosion in metallic elements (d).

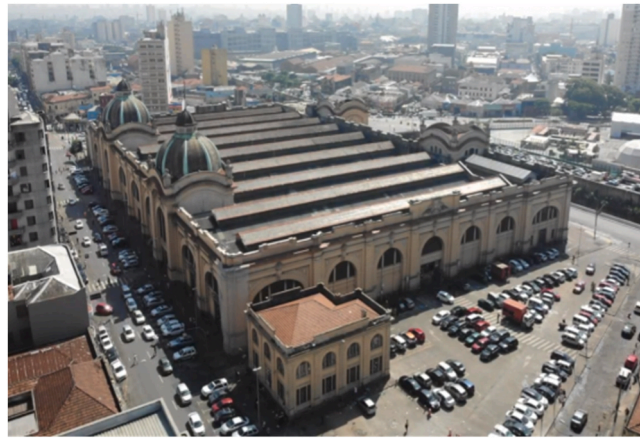
Fig. 4. The Municipal Market of São Paulo ('Mercadão').

In 2004, a partial restoration was performed in the building, respecting the premises of interventions in listed properties. During this restoration, infrastructure, drainage, electrical and hydraulic installations were revised. Besides, an area for restrooms, changing rooms, and a cafeteria for employees was constructed in the basement, and a mezzanine for restaurants was built. Currently, the Municipal Market of São Paulo suffers from a lack of maintenance operations. As a result, many building pathologies may be found, such as infiltration stains, mold, and detachment of the rendering mortar and painting of the façades.
